Kern River Home Inspections

Property Inspection Report

123 Example, Bakersfield, CA
Inspection prepared for: Home Buyer
Date of Inspection: 10/10/2017 Time: 9:00 AM
Age of Home: Built in 2004 Size: 3136 Sq.Ft.
Weather: 74°F to 82°F

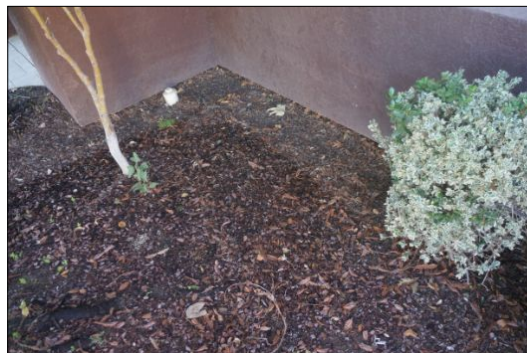
GROUNDS Grading

The grounds surrounding the structure had areas of neutral or negative drainage that will route runoff from precipitation toward the foundation. Excessively high moisture levels in soil supporting the foundation can effect its ability to support the weight of the structure above.

The ground should slope away from the home a minimum of $\frac{1}{4}$ -inch per foot for a distance of at least six feet from the foundation.

The Inspector recommends re-grading these areas to improve drainage near the foundation.

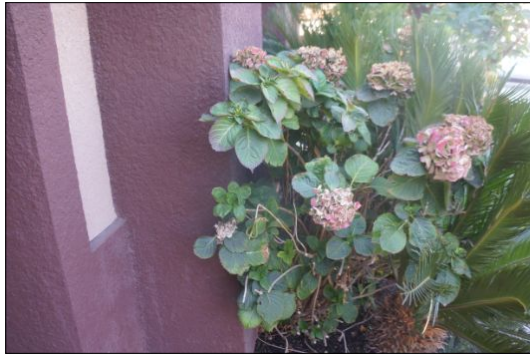
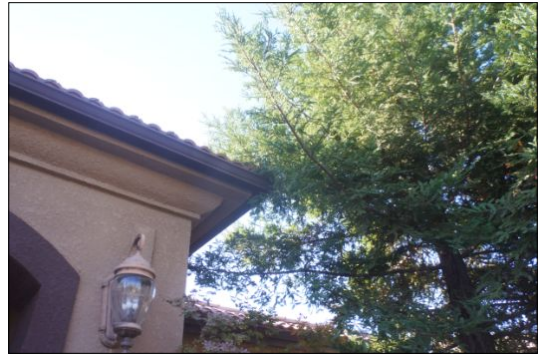
GROUNDS Vegetation Observations

- There is vegetation in contact with the structure of the home. Foliage should be maintained so it is at least 10 to 12 inches away from the home as it may cause physical damage to the exterior and promote high moisture conditions and / or infestation. Where foliage is dense and access limited, hidden conditions may exist.

detremental to the aesthetic appearance of the home. If the foliage is left in place, be aware that infestation and high moisture conditions may occur. Regular and periodic inspections are recommended.

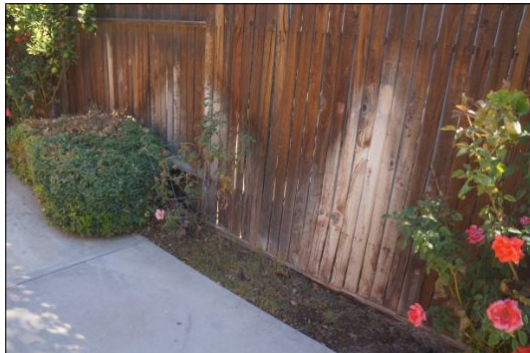
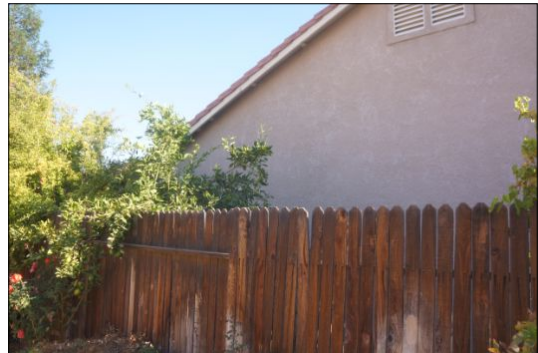
GROUNDS Fence Condition

- Fences had sections that needed maintenance to be performed.

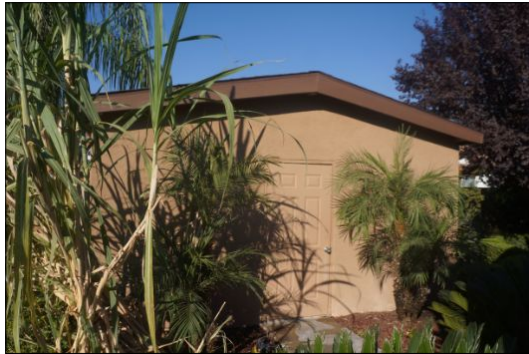
GROUPS Outbuildings Structure

- Stucco covering exterior walls of the outbuilding had minor damage visible at the time of the inspection.

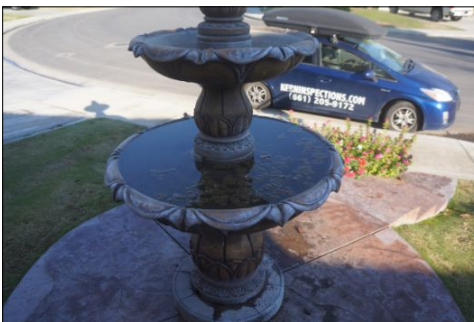
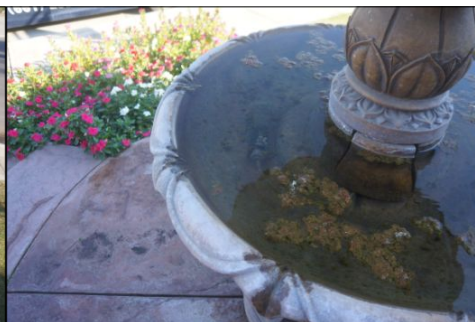
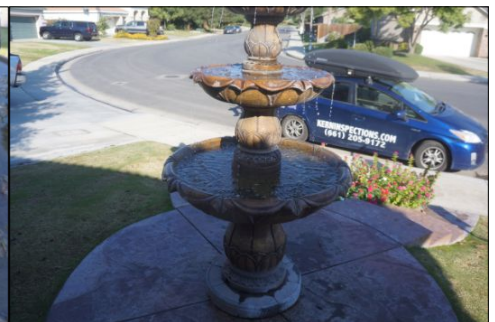
- The fountain appeared to be in serviceable condition at the time of the inspection.
- The fountain in the front yard appeared to have an auto-fill valve. The fountain was overflowing at the time of inspection. The auto fill valve may need adjustment or replacement.

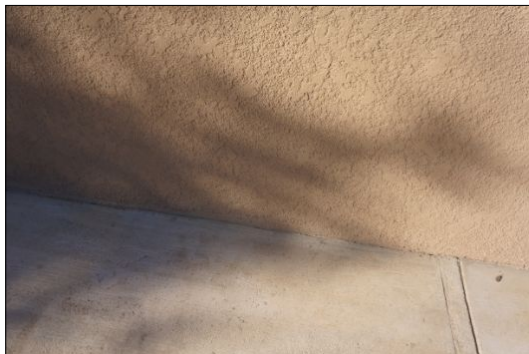
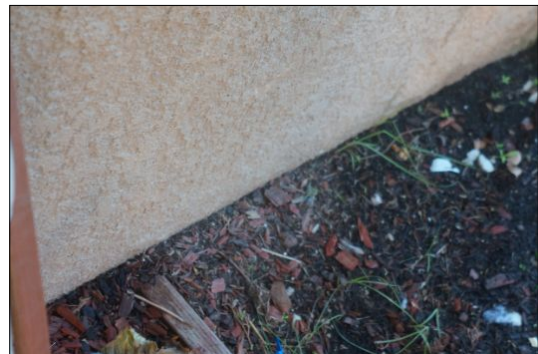
EXTERIOR WALLS Stucco/EIFS Instillation

- Stucco covering exterior walls of the home had inadequate clearance from grade. Stucco should terminate a minimum of 4 inches above grade (2in above concrete driveways, walkways or patios). The affected areas may require ongoing maintenance.

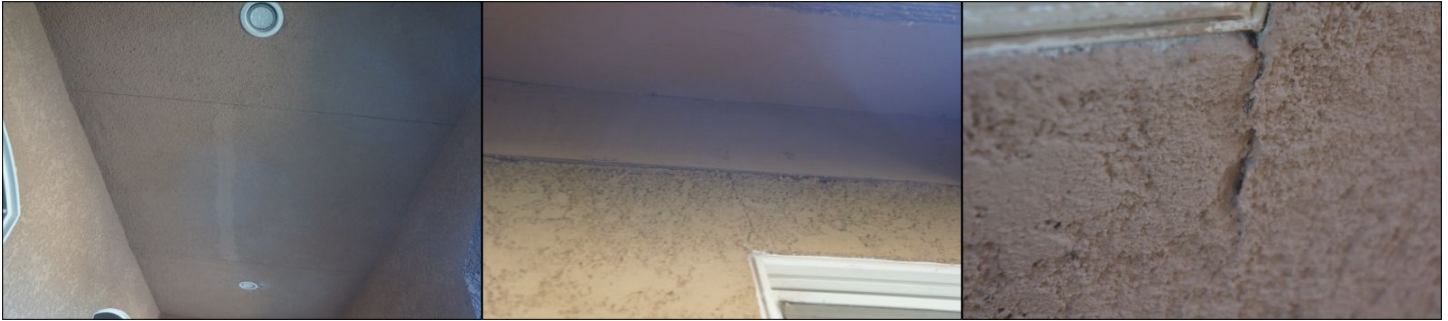
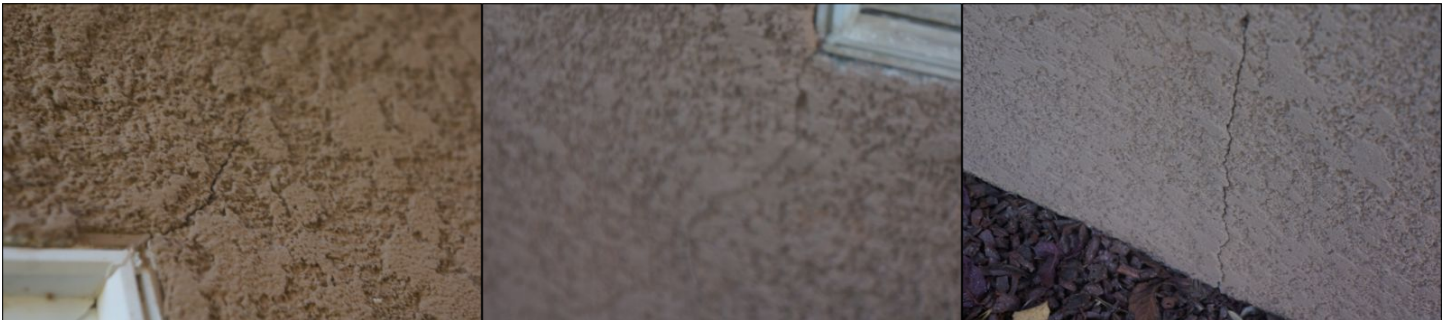
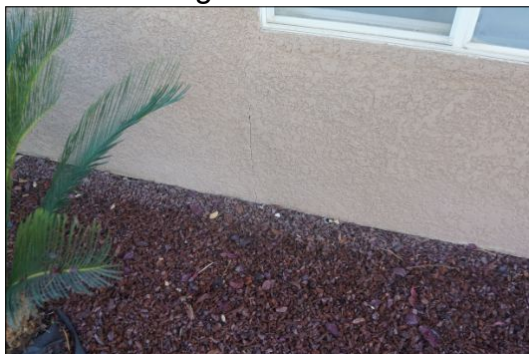
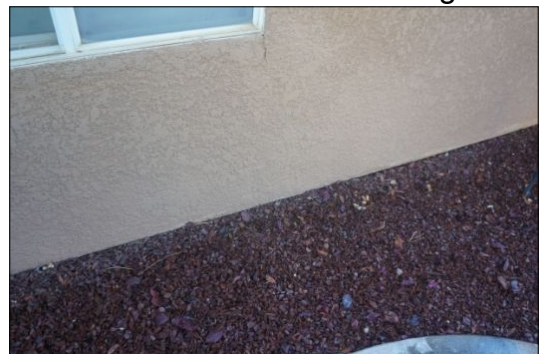
EXTERIOR WALLS Stucco/EIFS Cracking

General minor cracking, not uncommon in stucco covering exterior walls, was visible at the time of the inspection. This condition is typically the result of long-term thermal expansion and contraction and settling.

There were areas where long cracks in the stucco above the front porch which appeared to follow the joints of the underlying material. These cracks were thin and were in areas which were mostly protected from weather. At this point they appear to only be a cosmetic issue, but they should be monitored for change.

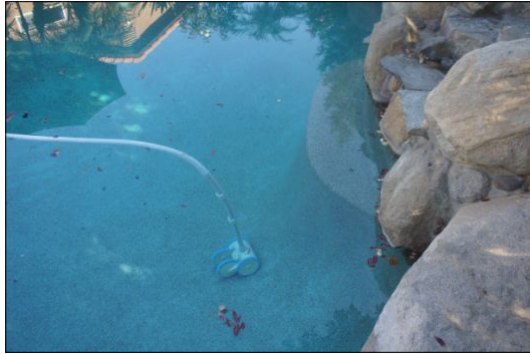
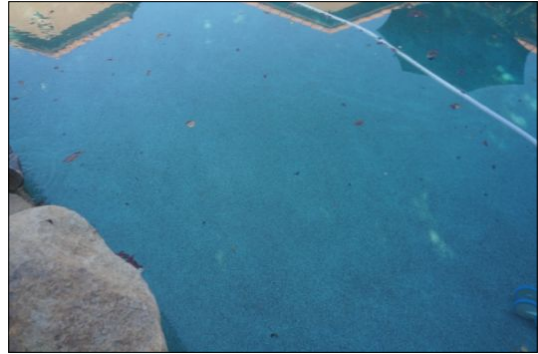
- The pool vessel appeared to be in serviceable condition.

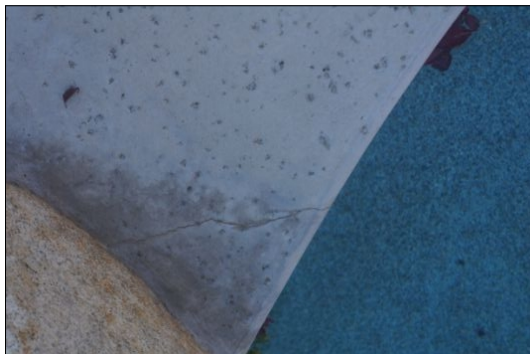
POOL Deck

- Minor common cracks were noted in the deck.

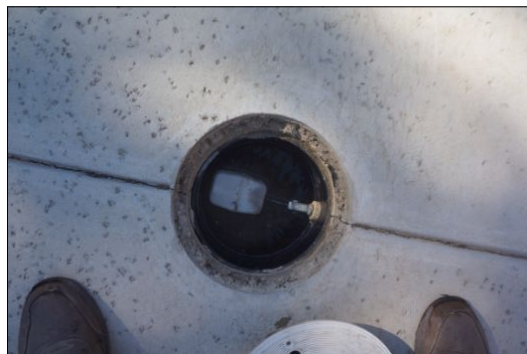
- The auto fill valve was tested and was functional.

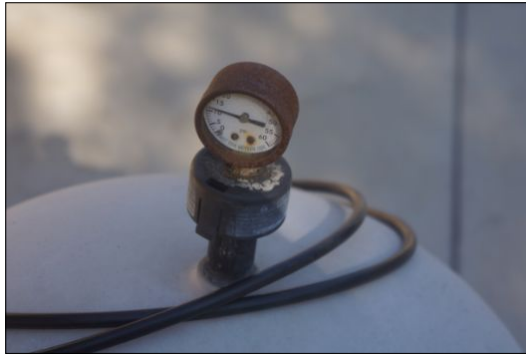
POOL Filters

- The fiberglass filter housing was weathered but still appeared serviceable.
- The pressure reading was a bit higher than the normal range. This can be normal for the pools system, or it could indicate that the filter needs cleaning. The inspector recommends servicing the filter and recording the normal operating pressure once the filter has been serviced. This recorded number should be the new baseline. Then in the future when the pressure rises 4 psi to 5 psi above that baseline, the filter should be serviced.

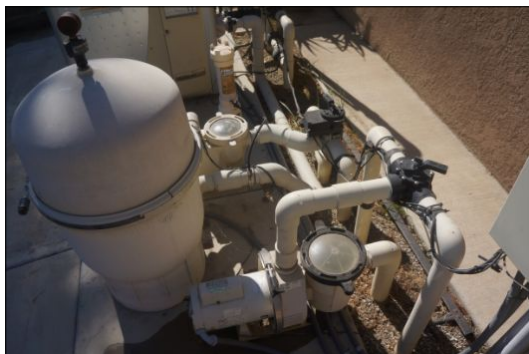
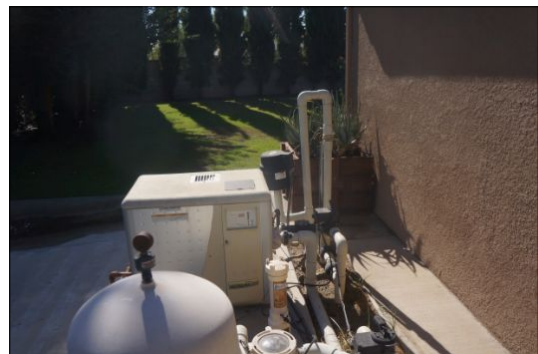
- Plumbing pipes appeared to be in serviceable condition at the time of the inspection.

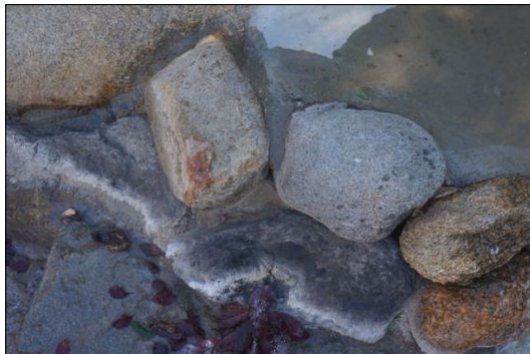
SPA Deck

- The rocks in the spa decking had small gaps in the mortar. Recommend repairs or replacement as needed.

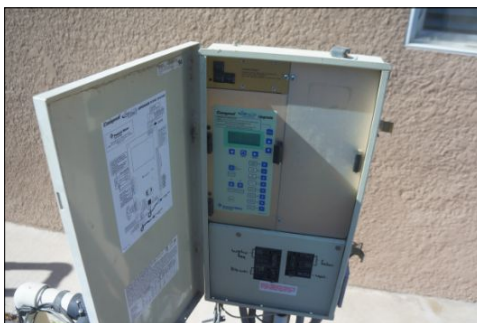
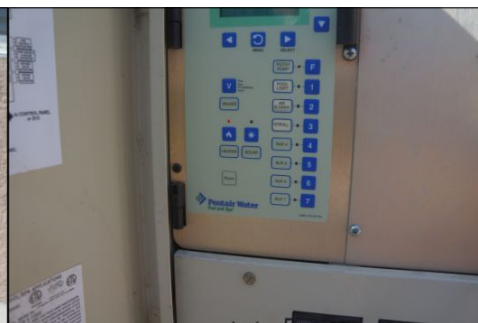
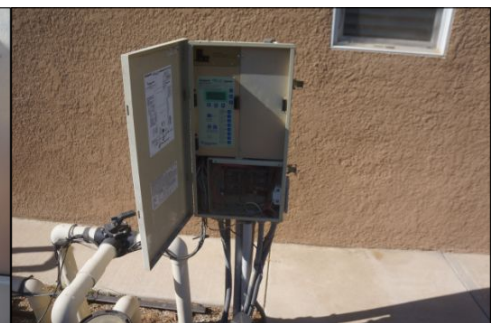
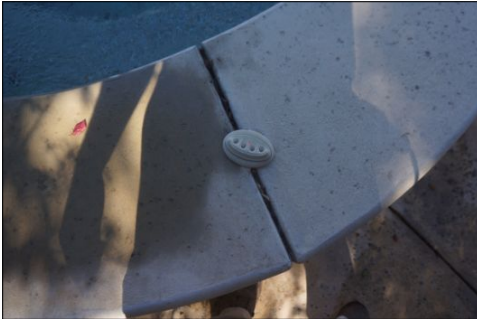
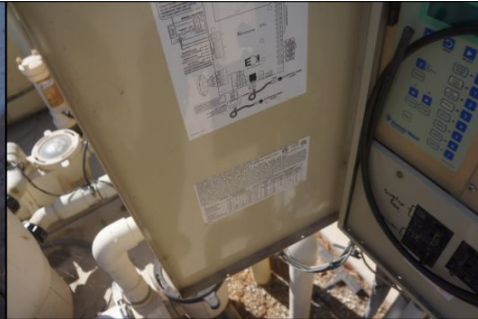
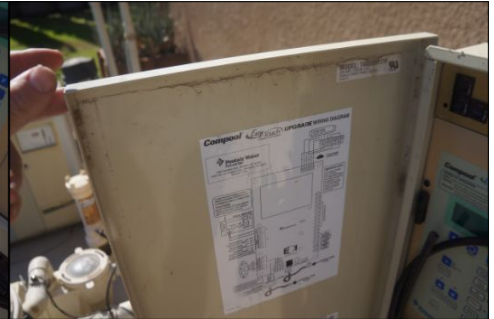
- The low voltage controller at the spa was flashing a red light but none of the buttons appear to change the function. Because the buttons were not labeled it was not clear what each button should be doing. Further review is recommended.
- The inspector changed the program to the spa setting. None of the automatic valves moved. It appears that the program needs to be adjusted for proper functionality for the spa to be used as a hot tub.

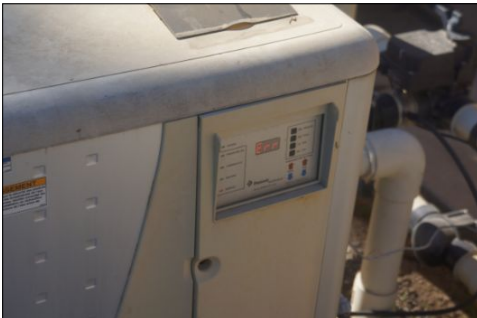
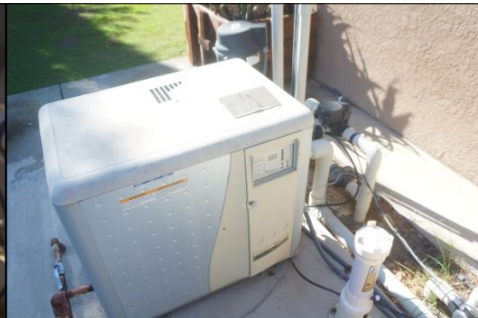
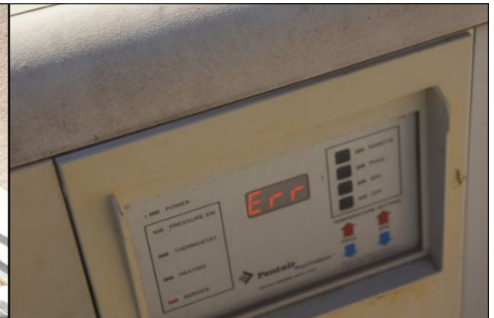
- The inspector attempted to run the heater several times but an error message would come up and the service light would come on each time. The spa/pool heater should be serviced by a qualified contractor.

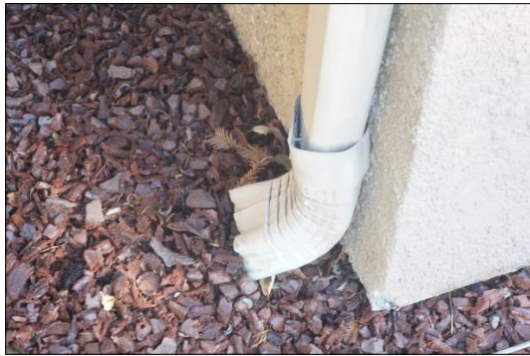
EXTERIOR ROOF STRUCTURE Roof Drainage System

- One or more downspouts at the home routed roof drainage to the foundation. This condition can result in excessively high moisture levels in soil at the foundation. Excessive moisture levels in soil near the foundation can effect the ability of the soil to support the weight of the structure above. The Inspector recommends repair of the roof drainage system to help protect the home structure and occupants
- Debris visible in the gutters at the time of the inspection should be removed to encourage proper drainage.

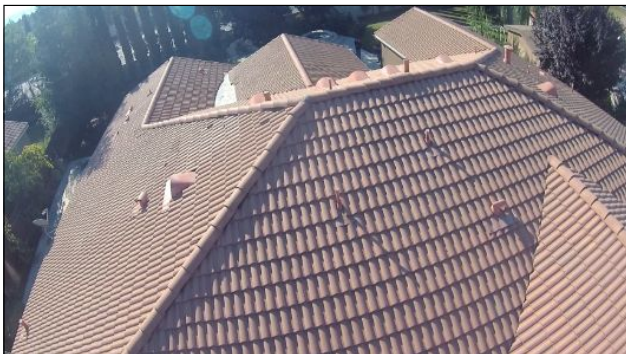
TILE ROOFS Concrete Tile

- The concrete roof tiles were a medium-profile type that interlocked edges with tiles in the same course. The interlocking profile creates a water channel that helps prevent moisture intrusion of the roof.

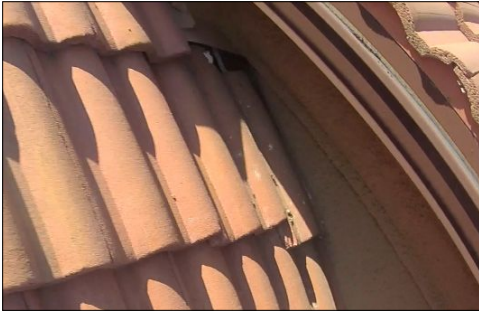
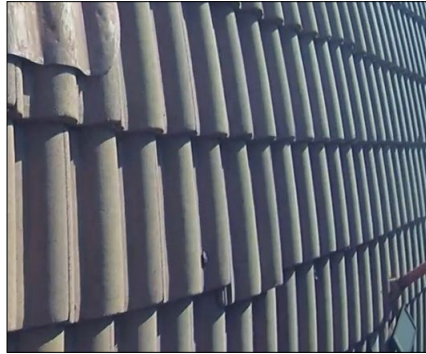
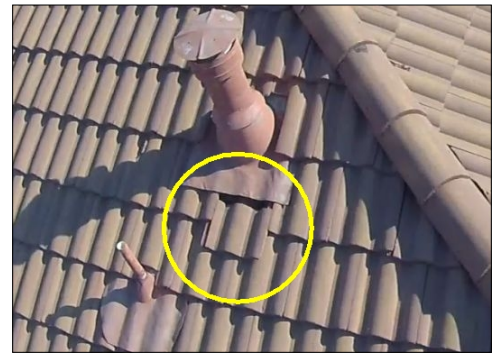
- Several roof tiles had slipped downhill. These tiles should be reinstalled or replaced by a qualified roofing contractor in a manner that will hold the tiles securely in place. The inspector also recommends that the rest of the roof is reviewed to ensure all required fasteners are installed.

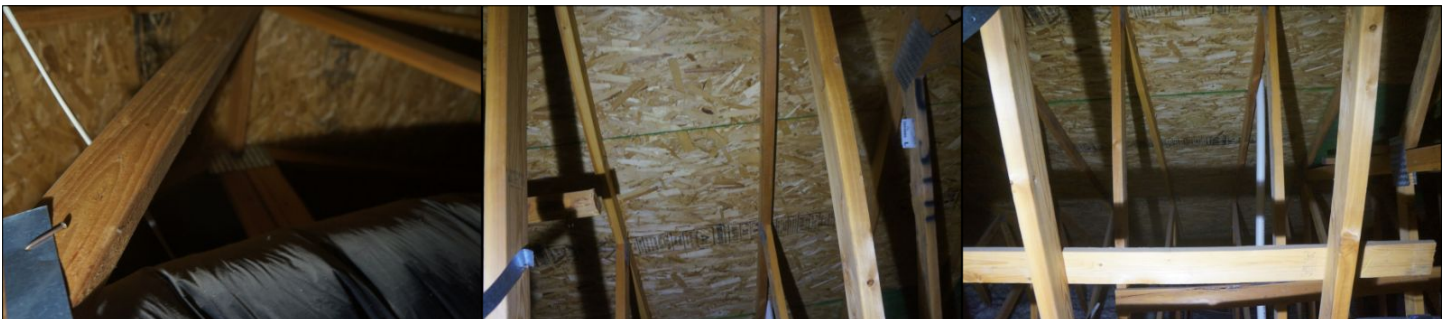
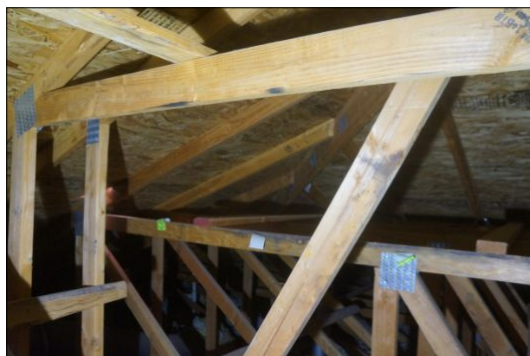
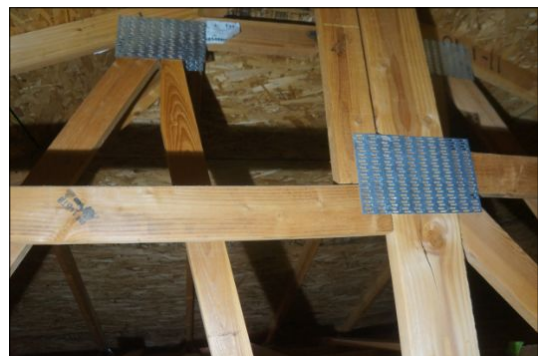
- The roof was framed using a combination of engineered (manufactured) roof trusses and conventional framing methods.

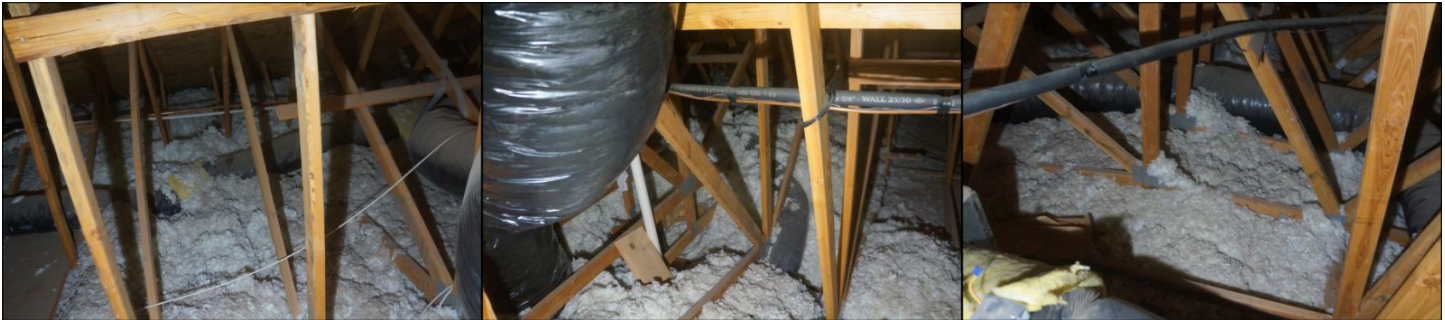
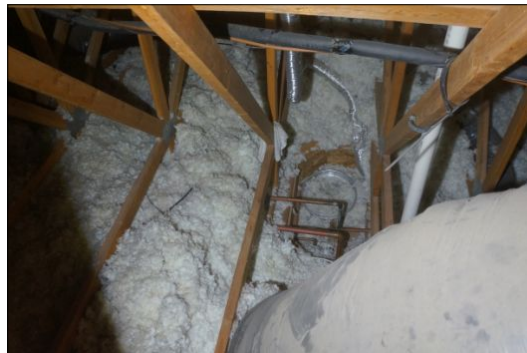
ATTIC Insulation Condition

- There were sections where insulation was trampled down.

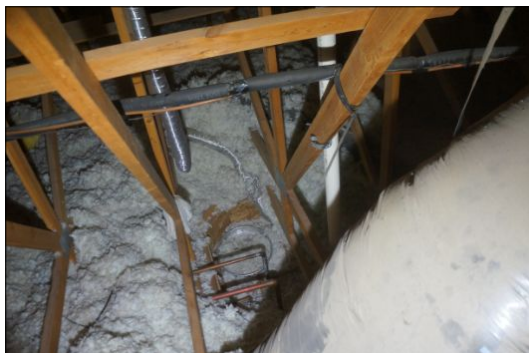
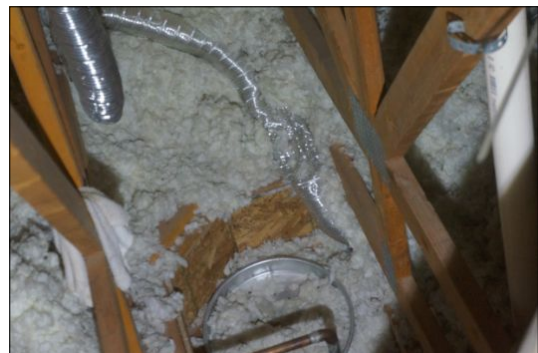
ATTIC Ventilation Condition

- There was exhaust duct in the attic that appeared to be crushed. The crushed duct should be repaired or replaced.

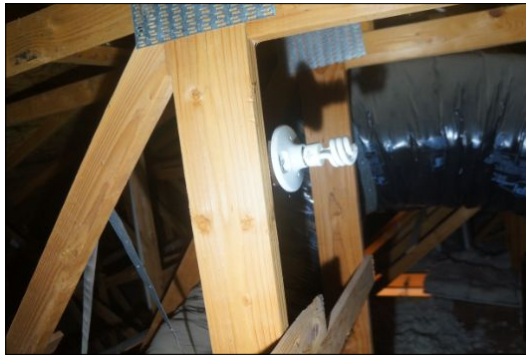
ATTIC Electrical

- A light fixture in the attic did not respond to the switch. The bulb may need to be replaced or there may be a problem with the switch, wiring or light fixture. If after the bulb is replaced this light still fails to respond to the switch, this condition may represent a potential fire hazard and the Inspector recommends that an evaluation and any necessary repairs be performed by a qualified electrical contractor.

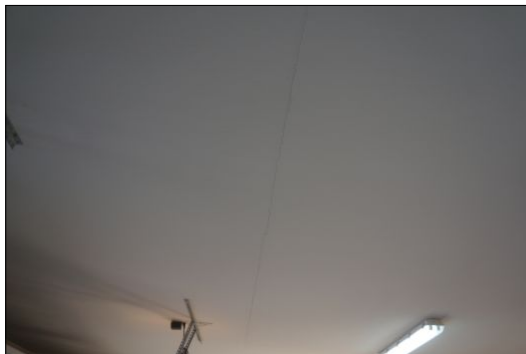
GARAGE Garage Ceiling

- Common cracks were noted in the drywall ceilings.

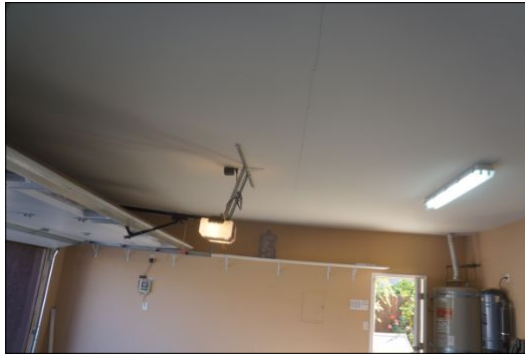
- Both automatic garage door openers responded to the controls and appeared to be in serviceable condition at the time of the inspection.

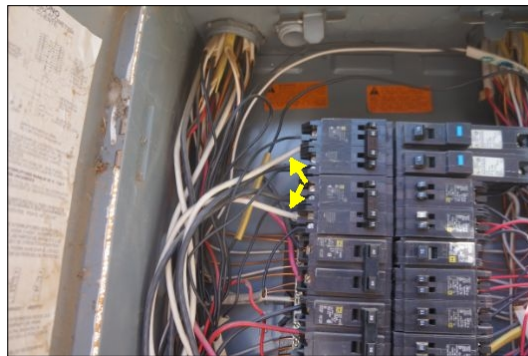
ELECTRICAL Main Panel Wiring Defects

- An improperly identified conductor was noted at the time of inspection. Identification can be by color coding, marking tape, tagging, or other means approved by the authority having jurisdiction. The inspector recommends that this conductor is evaluated and properly identified by a qualified electrical contractor.

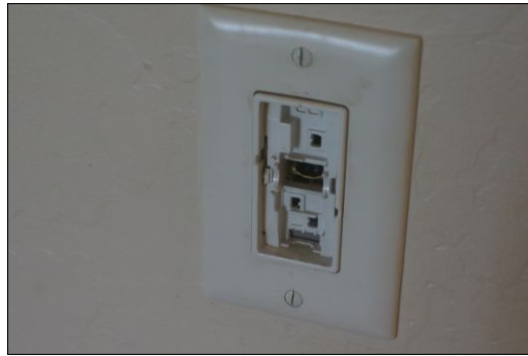
ELECTRICAL Lighting Fixtures

- Several light fixtures near the entry did not function. There was a broken switch noted which could be associated with the lights. The Inspector recommends that an evaluation and any necessary repairs be performed by a qualified electrical contractor.

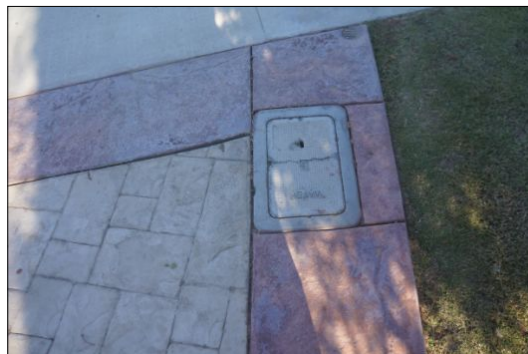
Water meter was in an underground box by the street.

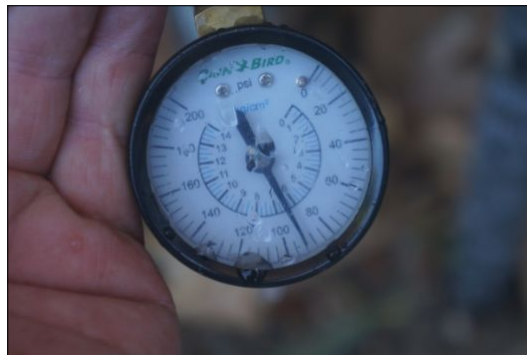
PLUMBING Water Pressure

- "Static" water pressure measured at a specific location and at a specific time. Static pressure is what you get when NO water is running. Once a faucet is turned on in the system the water pressure will vary. Your highest reading will be at the point where the supply line enters the home and it will go down as you progress towards the open faucet. Its the difference in pressure that drives the water through the lines.
- The static water pressure measured 90 pounds per square inch (psi) at the time of the inspection. Acceptable water pressure is between 40 and 90 psi.

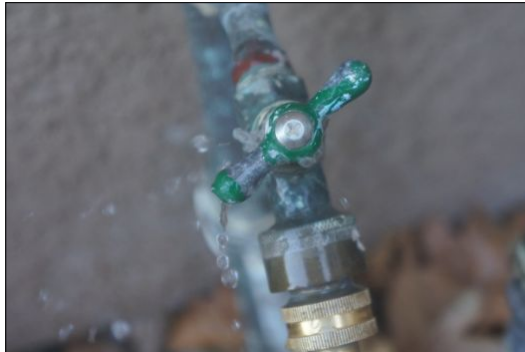
PLUMBING Exterior Faucets

- An exterior faucet leaked when pressurized in the on position when tested at the time of inspection. The valve should be repaired or replaced by a qualified plumbing contractor.

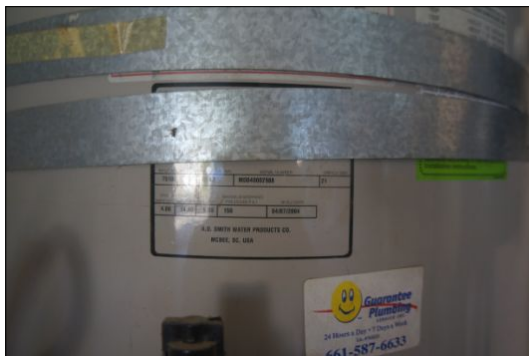
WATER HEATER Water Heater Data Plate Information

- Observations:
- This water heater was manufactured by A O Smith.
 - The date of manufacture appeared to be 2004.
 - Water heater capacity was 74 gallons.

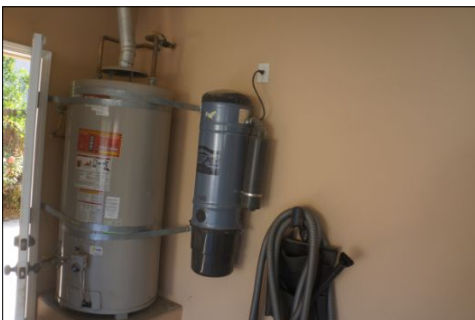
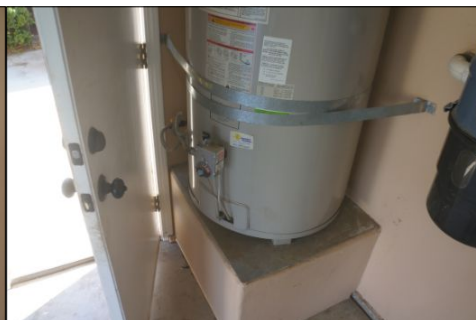
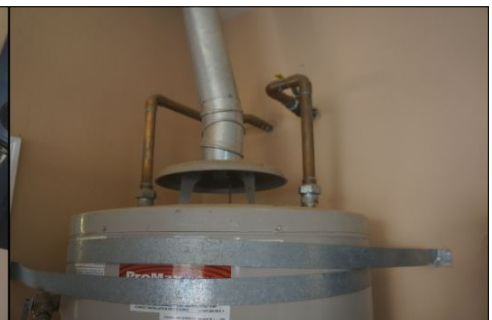
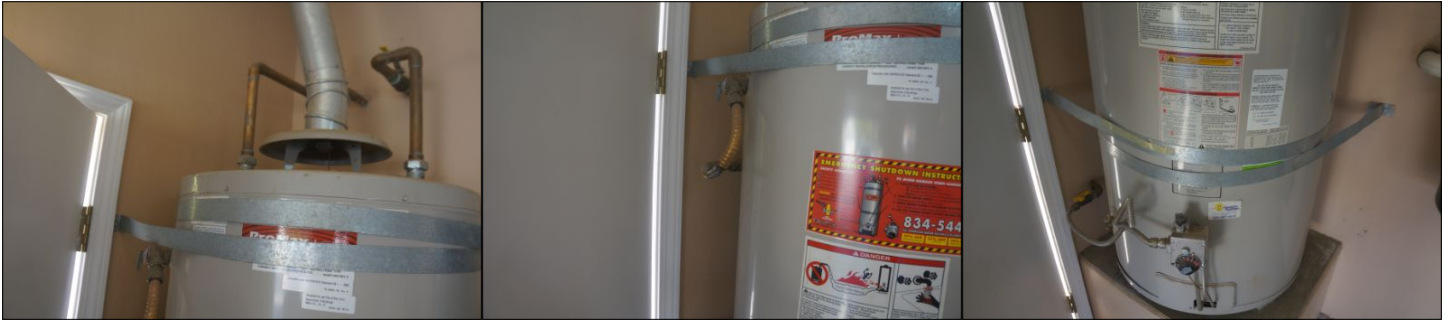
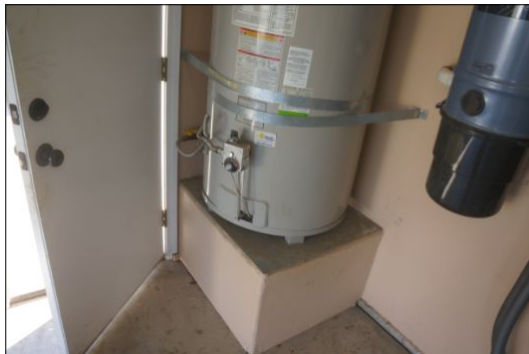
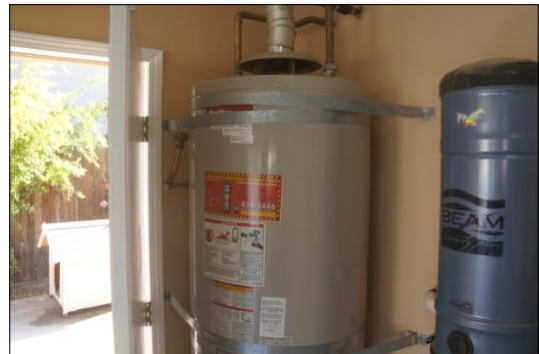
WATER HEATER General Condition

- Observations:
- Adequate seismic straps were noted at the time of inspection.
 - This water heater responded to the demand for hot water.
 - **Popping noises in water heaters are the result of mineral deposits that build up in the tank. As the water heats up, steam is produced at the deposits and makes popping noises when it releases. The water heater should be flushed and possibly delimed.**

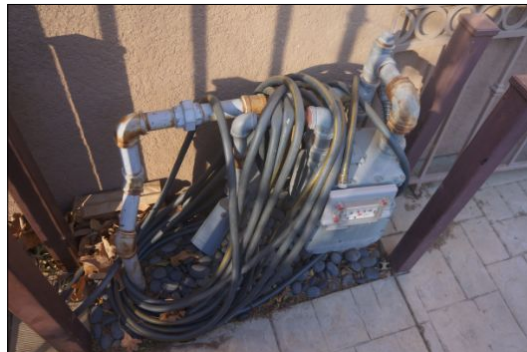
GAS SYSTEM Gas System Observations

- The structure was fueled by natural gas.

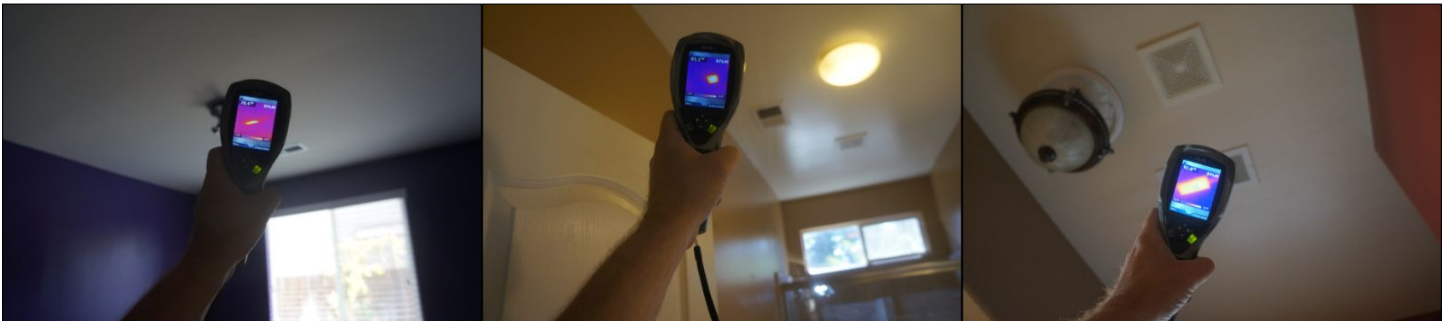
FURNACE Furnace Operation

- There were two furnaces in this home. Both responded adequately to the call for heat.

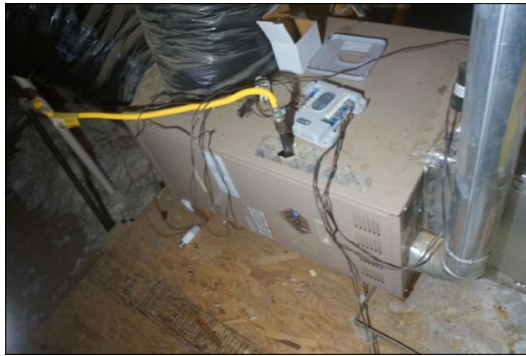
FURNACE General Condition

- All furnace components appeared to be in serviceable condition at the time of the inspection. Inspection of the furnace typically includes examination/operation of the following:
 - Cabinet interior and exterior
 - Fuel supply and shut-off (not tested)
 - Electrical shut-off
 - Adequate **combustion air**
 - Proper ignition
 - Burn chamber conditions (when visible)
 - Exhaust venting
 - Air filter and blower
 - Plenum and ducts
 - Response to the thermostat
 - Adequate return air
 - Automatic damper and controls
 - Condensate drain components
- The Inspector specifically disclaims furnace heat exchangers because a proper evaluation requires invasive, technically exhaustive measures which exceed the scope of the General Home Inspection. If there is any doubt about the condition of the heat exchanger, you should have the furnace certified by a qualified HVAC contractor.

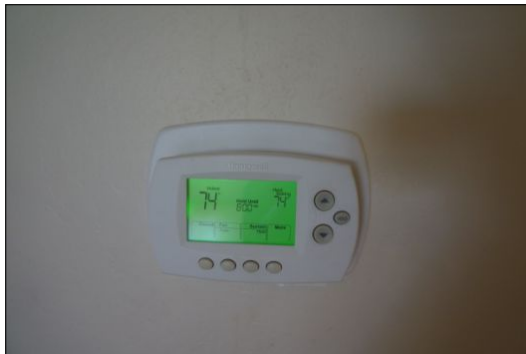
FURNACE Thermostat

- One of thermostat for the right side of the home was locked with a maximum heat setting of 74 degrees. Because of the temperature of the day, this limited the ability of the home inspector to fully test the operation of the heating system for this part of the home. The inspector attempted to override the 74-degree cap but was unable to do so. The heater function did operate for a very short period of time, so it was functional but full testing was not possible.

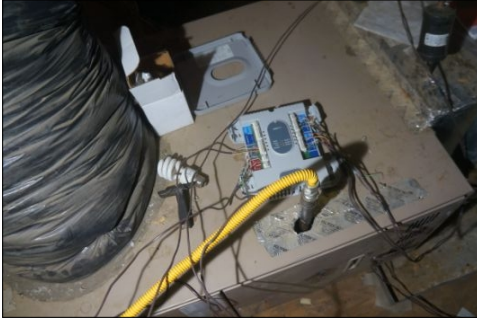
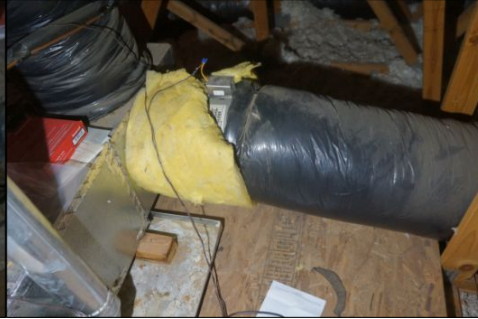
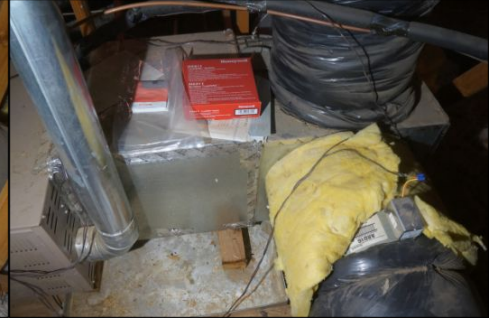
FURNACE Ducts

- An electronic damper was noted at furnace/air handler that supplied the right side of the home. The damper appeared to function as intended.

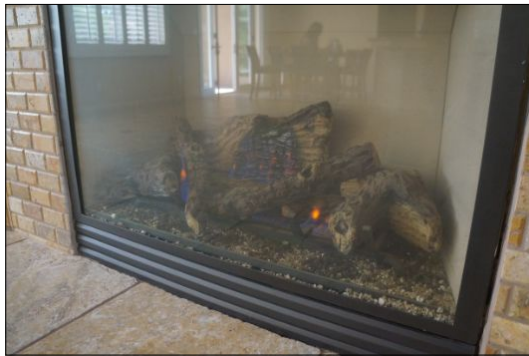
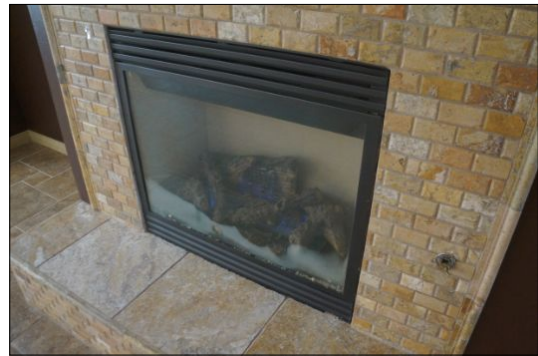
FIREPLACE Fireplace

- The home contained a gas-burning fireplace (also called "decorative gas appliance", "decorative gas fireplace", or just "gas fireplace"). It is not designed to burn solid-fuel, like wood.
- The gas-fueled fireplace appeared to be in serviceable condition and responded to the controls.

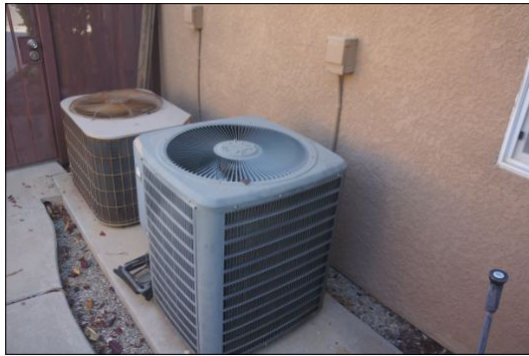
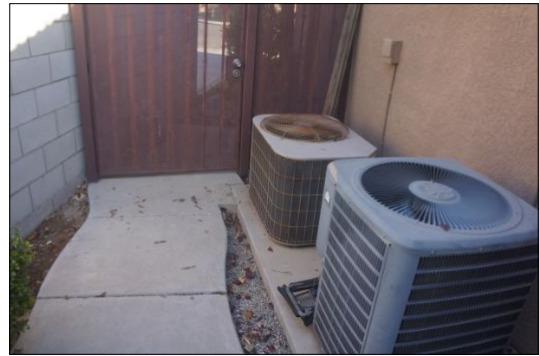
CENTRAL AIR CONDITIONING Cooling System
Description

- The home had two air-conditioning systems. The air conditioning systems were split systems in which the cabinets housing the compressors, cooling fans and condensing coils were located physically apart from the evaporator coils. As is typical with split systems, the compressor/condenser cabinets were located at the home's exterior so that the heat collected inside the home could be released to the outside air. Evaporator coils designed to collect heat from the home interior were located inside the air ducts at the furnaces.

- The first air-conditioner brand was York.
- The second air-conditioner brand was Goodman.

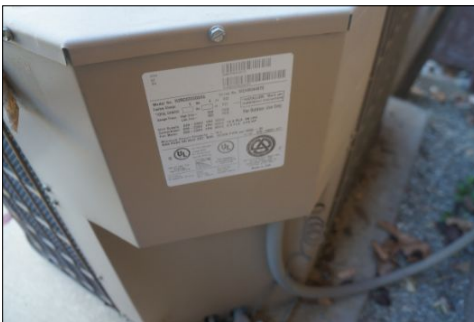
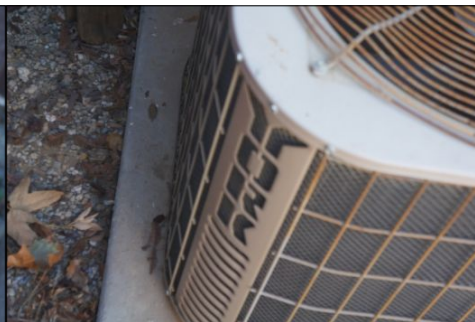
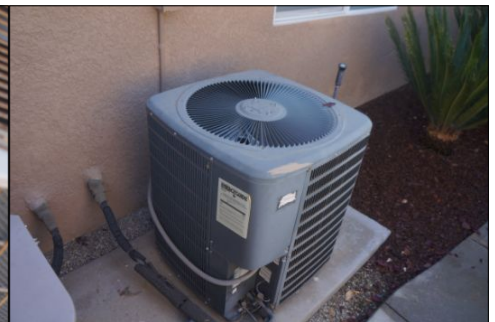
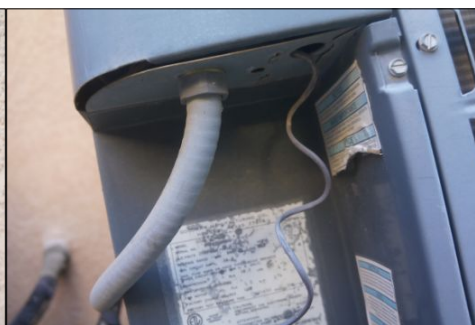
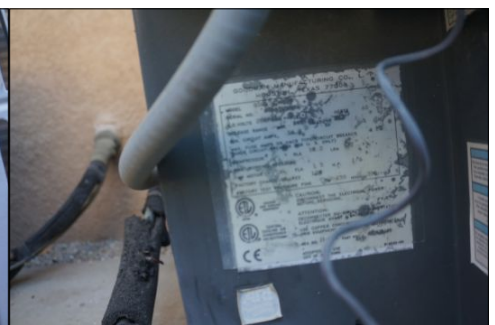
CENTRAL AIR CONDITIONING Cooling System Data Plate

- The first central air conditioning system serial number was WENM044672.
- The first air-conditioner date of manufacture appeared to be 2004.
- Much of the manufacture data plate of the second air-conditioner was weathered, faded, and difficult to read.

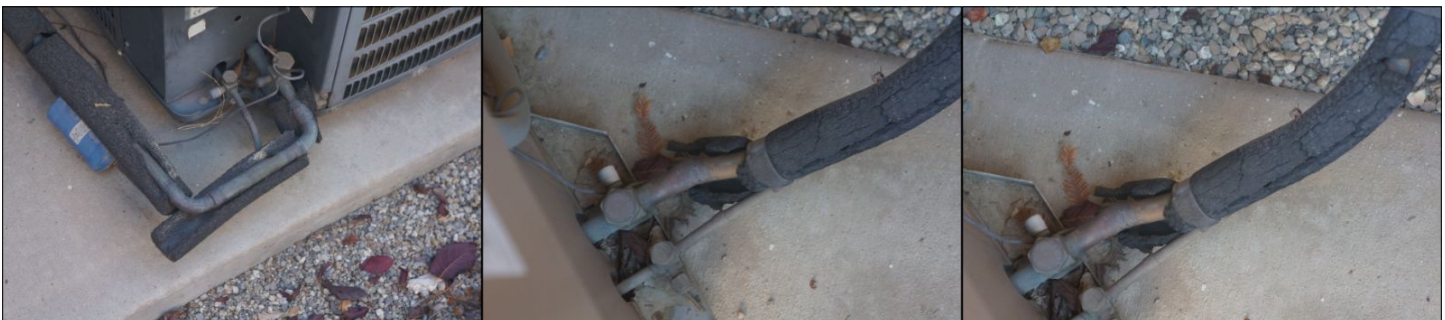
CENTRAL AIR CONDITIONING AC Refrigerant Lines

- Insulation on the air-conditioning suction (large, insulated) line was damaged or missing at areas and should be supplemented or replaced.

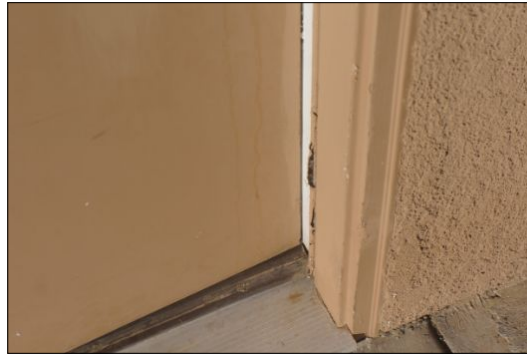
DOORS Weatherstripping

At the time of the inspection, weather-stripping at the garage personnel exterior door was damaged or deteriorated and should be replaced to help prevent air/heat leakage which will increase heating/cooling costs and reduce home comfort.

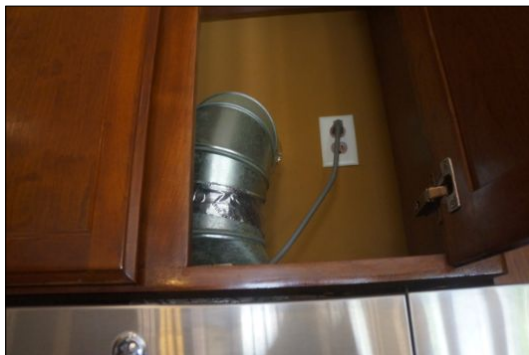
KITCHEN Range Hood

- The range hood exhaust fan appeared to be in serviceable condition at the time of the inspection.
 - The exhaust vent of the range hood appeared to discharge exhaust to the home exterior.
 - Range hood lights were inoperable at the time of the inspection. The bulb may be burned out, or there may be a problem with the switch, wiring or light fixture.
- If after replacing the bulb the light fixture still does not respond, the Inspector recommends correction by a qualified contractor.

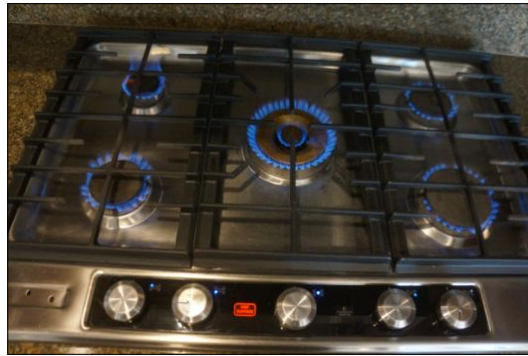
KITCHEN Cooktop/Downdraft

- The home was equipped with a gas-fired cooktop and separate built-in oven instead of a range. The cooktop appeared to be operating normally and in serviceable condition at the time of the inspection.

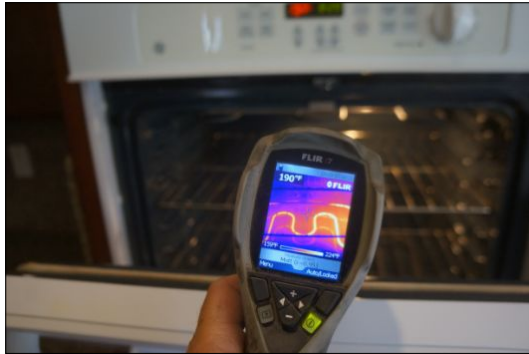
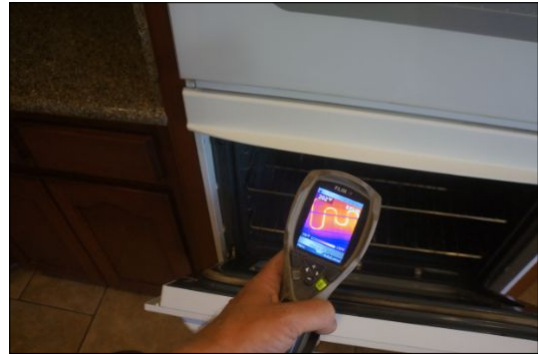
KITCHEN Built-in Oven

- The electric built-in oven was tested with the bake function. It appeared to be in serviceable condition at the time of the inspection.

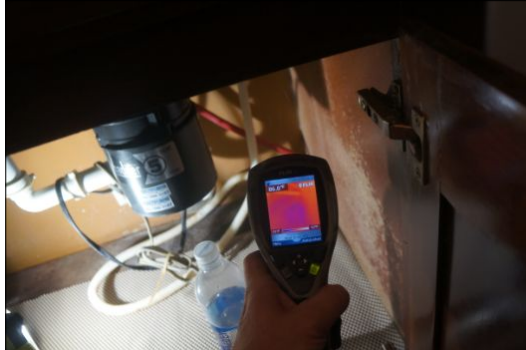
KITCHEN Undersink Conditions

- The floor of the kitchen sink cabinet was wet. The source of the leak was not obvious. The source of the leak should be located and the condition corrected to avoid further damage to the cabinets and wall/floor structure.

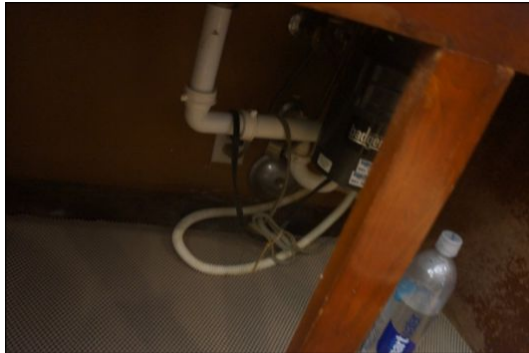
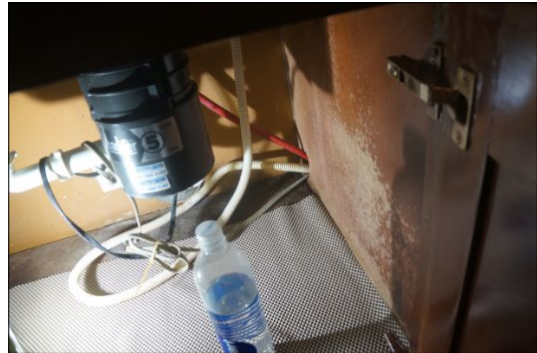
KITCHEN Garbage Disposal

- The garbage disposal responded when the switch was activated and appeared to be in serviceable condition at the time of the inspection.

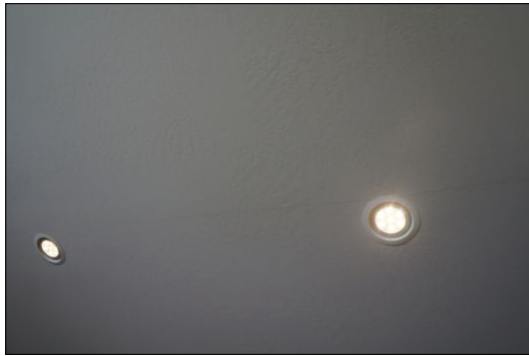
KITCHEN Ceilings

- There was a crack in the kitchen ceiling appeared to follow the edges of the drywall.

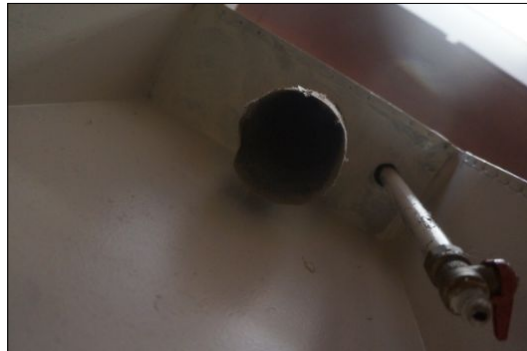
LAUNDRY Dryer Venting

The dryer vent connection was examined visually only. A visual examination will not detect the presence of lint accumulated inside the vent, which is a potential fire hazard.

The Inspector recommends that you have the dryer vent cleaned at the time of purchase and annually in the future to help ensure that safe conditions exist. Lint accumulation can occur even in approved, properly installed vents.

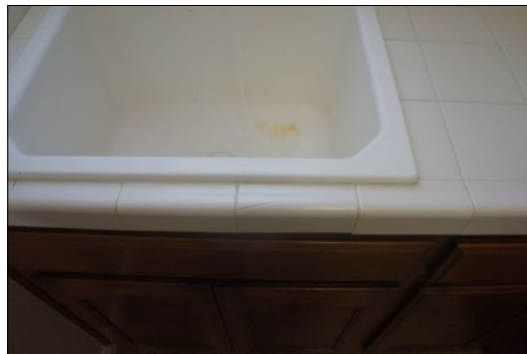
LAUNDRY Cabinets

- The laundry counter had cracked tile visible at the time of the inspection.

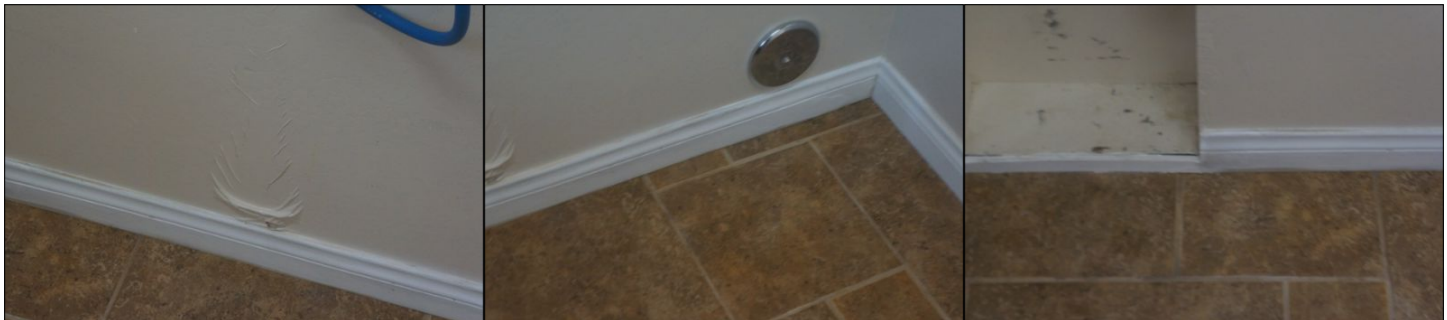
LAUNDRY Walls

- The wall near the window in the laundry room was noted with damage in the paint at the time of inspection.
- The walls and the interior trim in the laundry room had visible moisture damage. All damaged materials should be corrected by a qualified contractor.

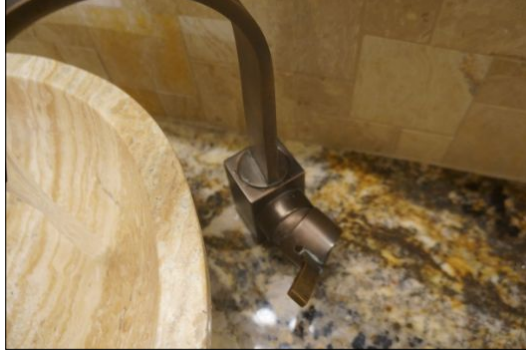
MASTER BATHROOM Sinks

- One sink faucet in this bathroom has the hot and cold water reversed. This is a safety issue as someone thinking they are turning on the cold water could scald themselves by accident. Repair as needed.
- One sink faucet in this bathroom was loose and leaked from the base when operated. The faucet should be repaired or replaced.

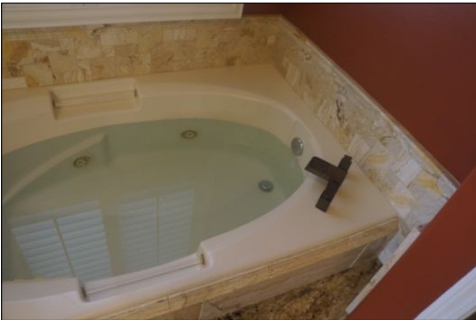
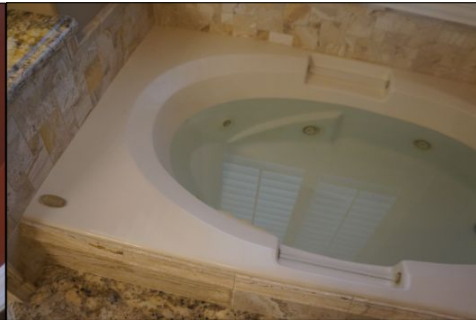
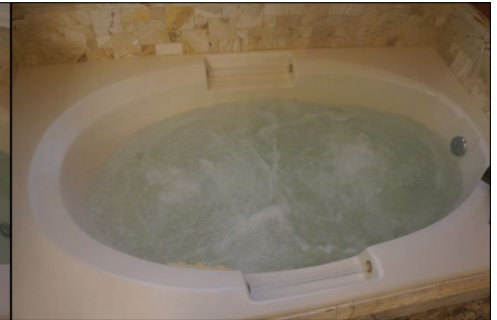
MASTER BATHROOM Bath
Tubs

- This bathtub had jets. The jets were operational at the time of the inspection.
- The jetted tub was protected by a GFCI outlet located in a closet.
