Kern River Home Inspections

Property Inspection Report

123 Example, Bakersfield, CA
Inspection prepared for: Home Buyer
Date of Inspection: 10/10/2017 Time: 9:00 AM
Age of Home: Built in 2004 Size: 3136 Sq.Ft.
Weather: 74°F to 82°F

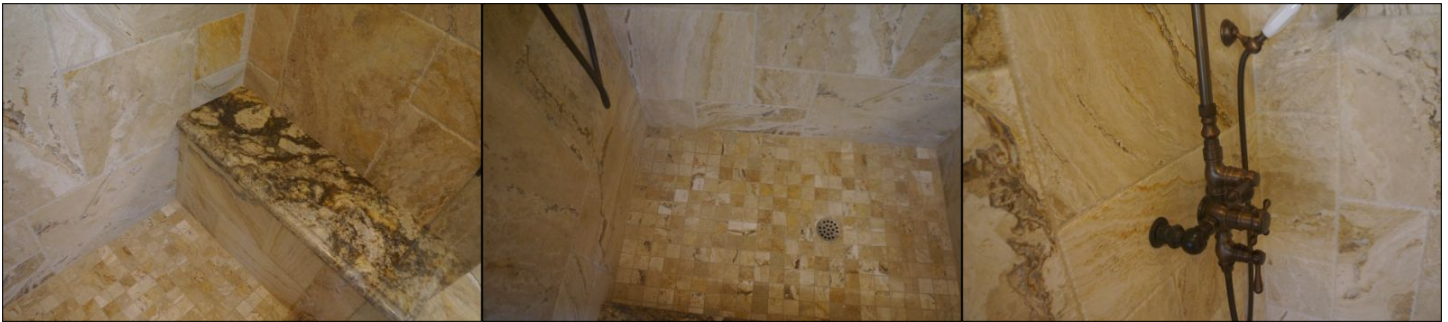
MASTER BATHROOM Shower MASTER BATHROOM Shower MASTER BATHROOM Shower

- The shower head had an erratic spray pattern. The shower head should be cleaned to avoid spraying outside the shower enclosure.

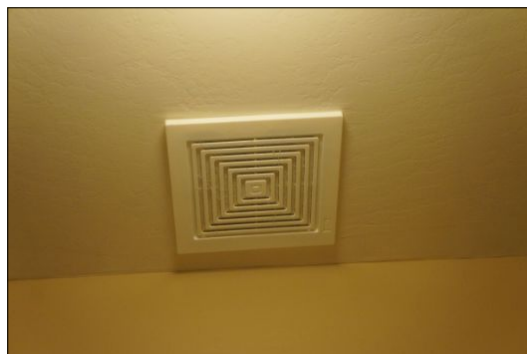
MASTER BATHROOM Bathroom Ventilation

- This bathroom had an operable source of ventilation at the time of the inspection.

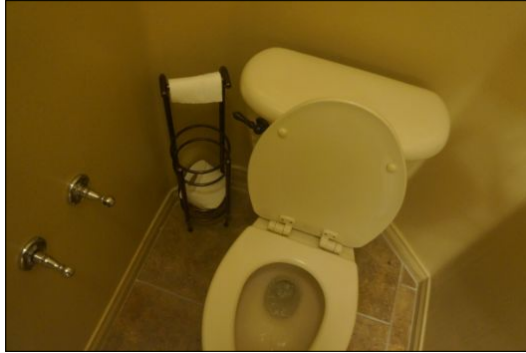
BATHROOM 2 Toilet Operation

- The toilet in this bathroom was flushed and operated in a satisfactory manner.

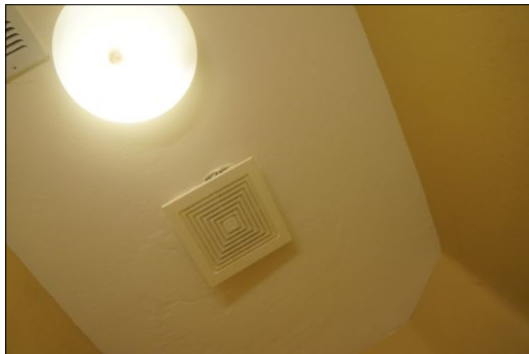
BATHROOM 2 Bathroom Ventilation

- The cover to the ventilation fan was loose. This should be reinstalled.

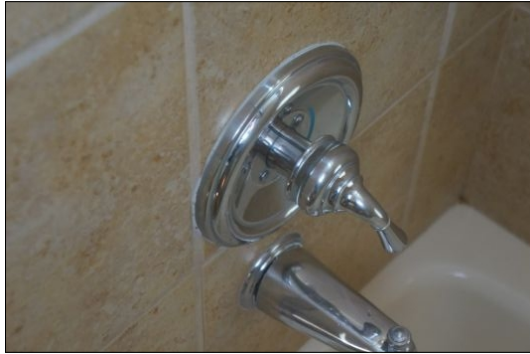
BATHROOM 3 Bath Tubs

- The bathtub did not have a stopper installed. Install as needed.
- A faucet handle at the tub in this bathroom was inoperable. This should be repaired or replaced.

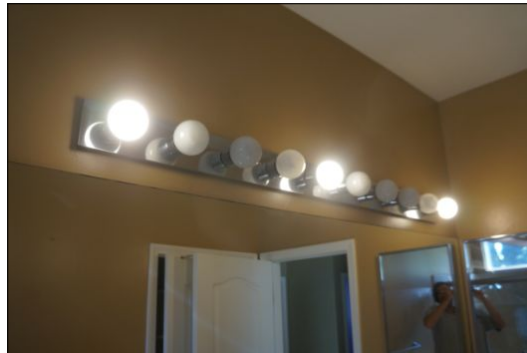
BATHROOM 3 Light Fixtures

If after the bulbs are replaced this lights still fails to respond to the switch, the Inspector recommends that an evaluation and any necessary repairs be performed by a qualified electrical contractor.

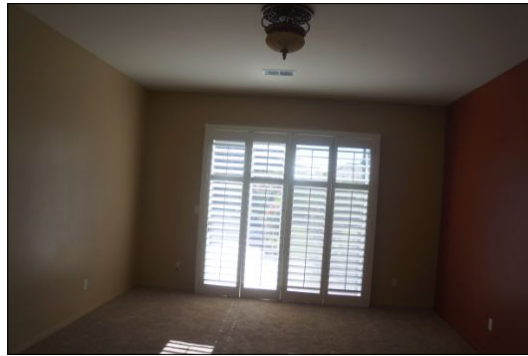
MASTER BEDROOM General Condition

- The master bedroom appeared to be in serviceable condition at the time of the inspection.

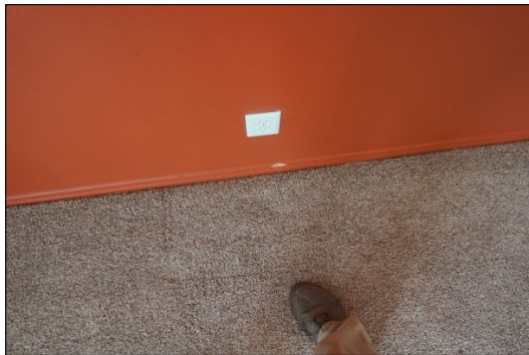
MASTER BEDROOM Interior Trim

- Minor trim damage was noted in this bedroom.

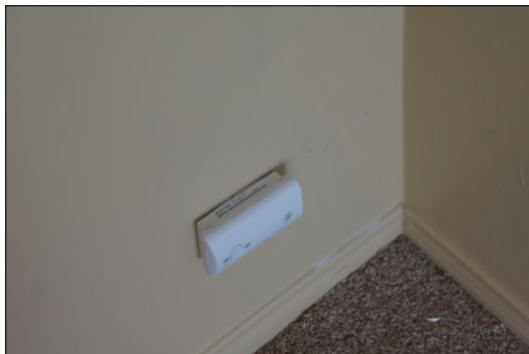
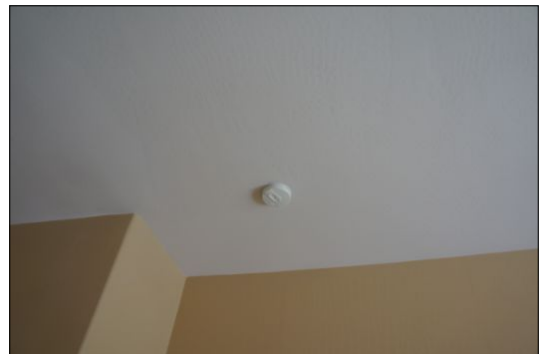
MASTER BEDROOM Smoke/CO Detectors

- A carbon monoxide and smoke detector were noted in this bedroom.

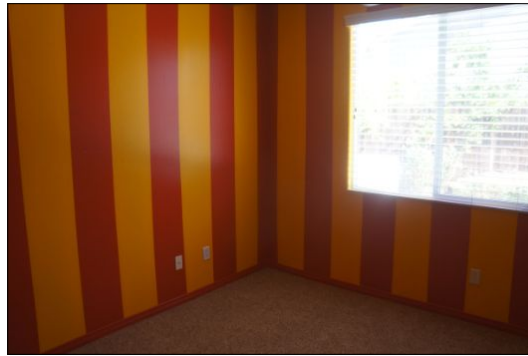
BEDROOM 2 General Condition

- This bedroom appeared to be in generally serviceable condition at the time of the inspection. Notable exceptions will be listed in this report.

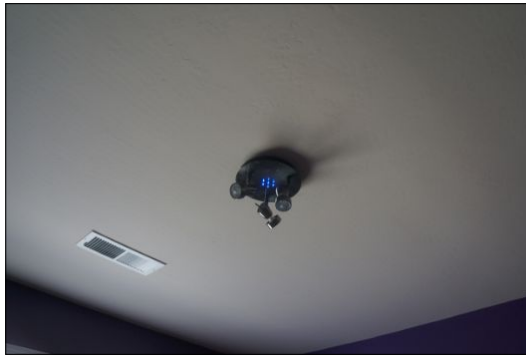
BEDROOM 3 Lighting Fixtures

- The light fixtures in this bedroom had LED lights and larger lights. The larger lights did not respond to the switch. The bulb may need to be adjusted, repaired or replaced for proper operation.

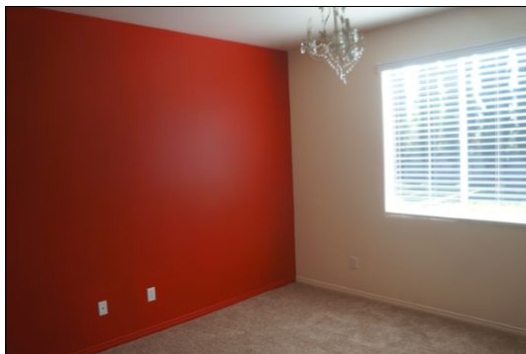
BEDROOM 4 General Condition

- Most components in this bedroom appeared to be in serviceable condition at the time of the inspection. Notable exceptions will be listed in this report.

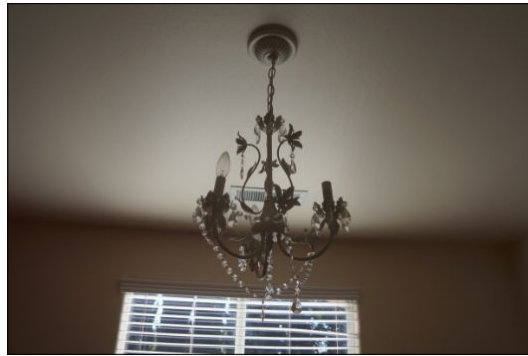
BEDROOM 4 Lighting Fixtures

- The light fixtures in this bedroom had missing and damaged bulbs.

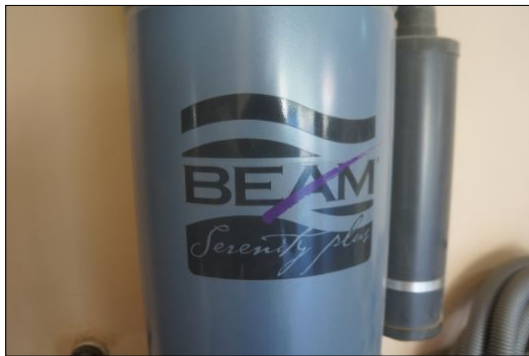
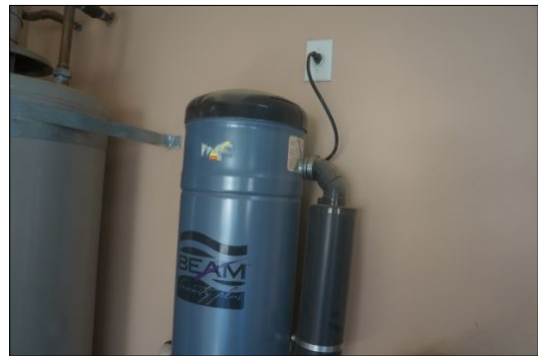
GENERAL INTERIOR General Condition

- The home had a central vacuum system. It was tested by switching it on using the manual switch on the unit and appeared to function properly. Testing every outlet for full suction lies beyond the scope of a general home inspection.
- **The doorbell was inoperable at the time of the inspection.**

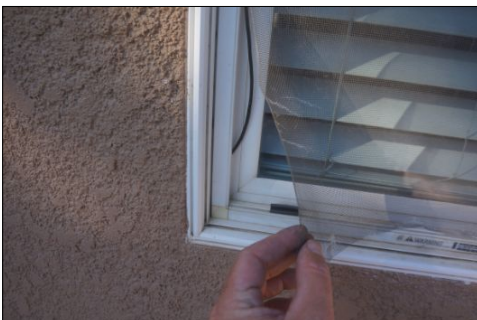
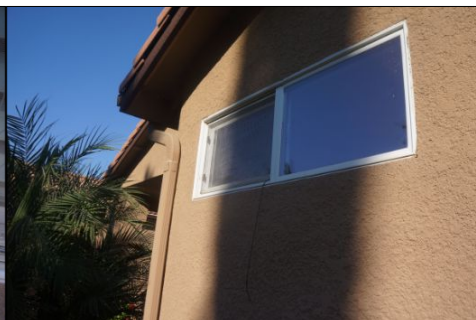
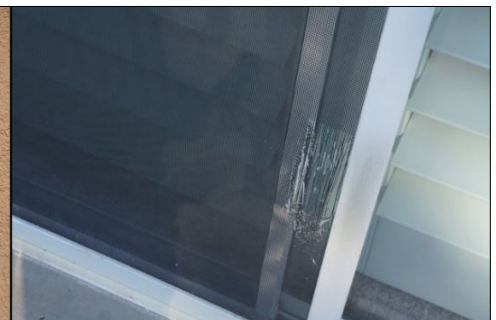
WINDOWS Screens & Blinds

- There were damaged screens noted in various areas. Repair or replace as needed.
